ADAPTRONICS, INC.

9 FINAL TECHNICAL REPORT, 15 Mar 78 - 15 Mar 81

6 DEVELOPMENT OF AN ADVANCED, AUTOMATIC, ULTRASONIC NDE IMAGING SYSTEM VIA ADAPTIVE LEARNING NETWORK SIGNAL PROCESSING TECHNIQUES.

Under Contract NDA903-78-C-0223, (A03553)
25 DARPA Order-3553

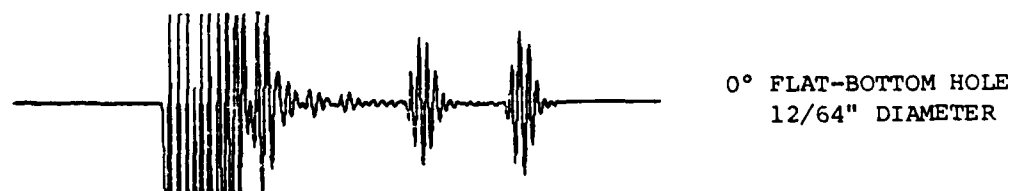
FIGURE 4.6: EXAMPLES OF PULSE-ECHO RECORDINGS
OBTAINED FROM THE INBOARD ARRAY

Examples of pulse-echo recordings obtained from a 0° flat-bottom and a round-bottom hole are shown in Figure 4.6. The large amplitude signals identified in these waveforms can be correlated with the front surface return, the defect response, the reflection from the backwall of the block, and various multiple reflections. Equations similar to those determined for the outboard T/R can
